# **Southern Lakes Roadways Invasive Plant “Patrol and Pull” Project Year 2 Report – 2016**

**Prepared for:  
Government of Yukon  
Department of Highways & Public Works  
Transportation Maintenance Branch**

**October 31, 2016**

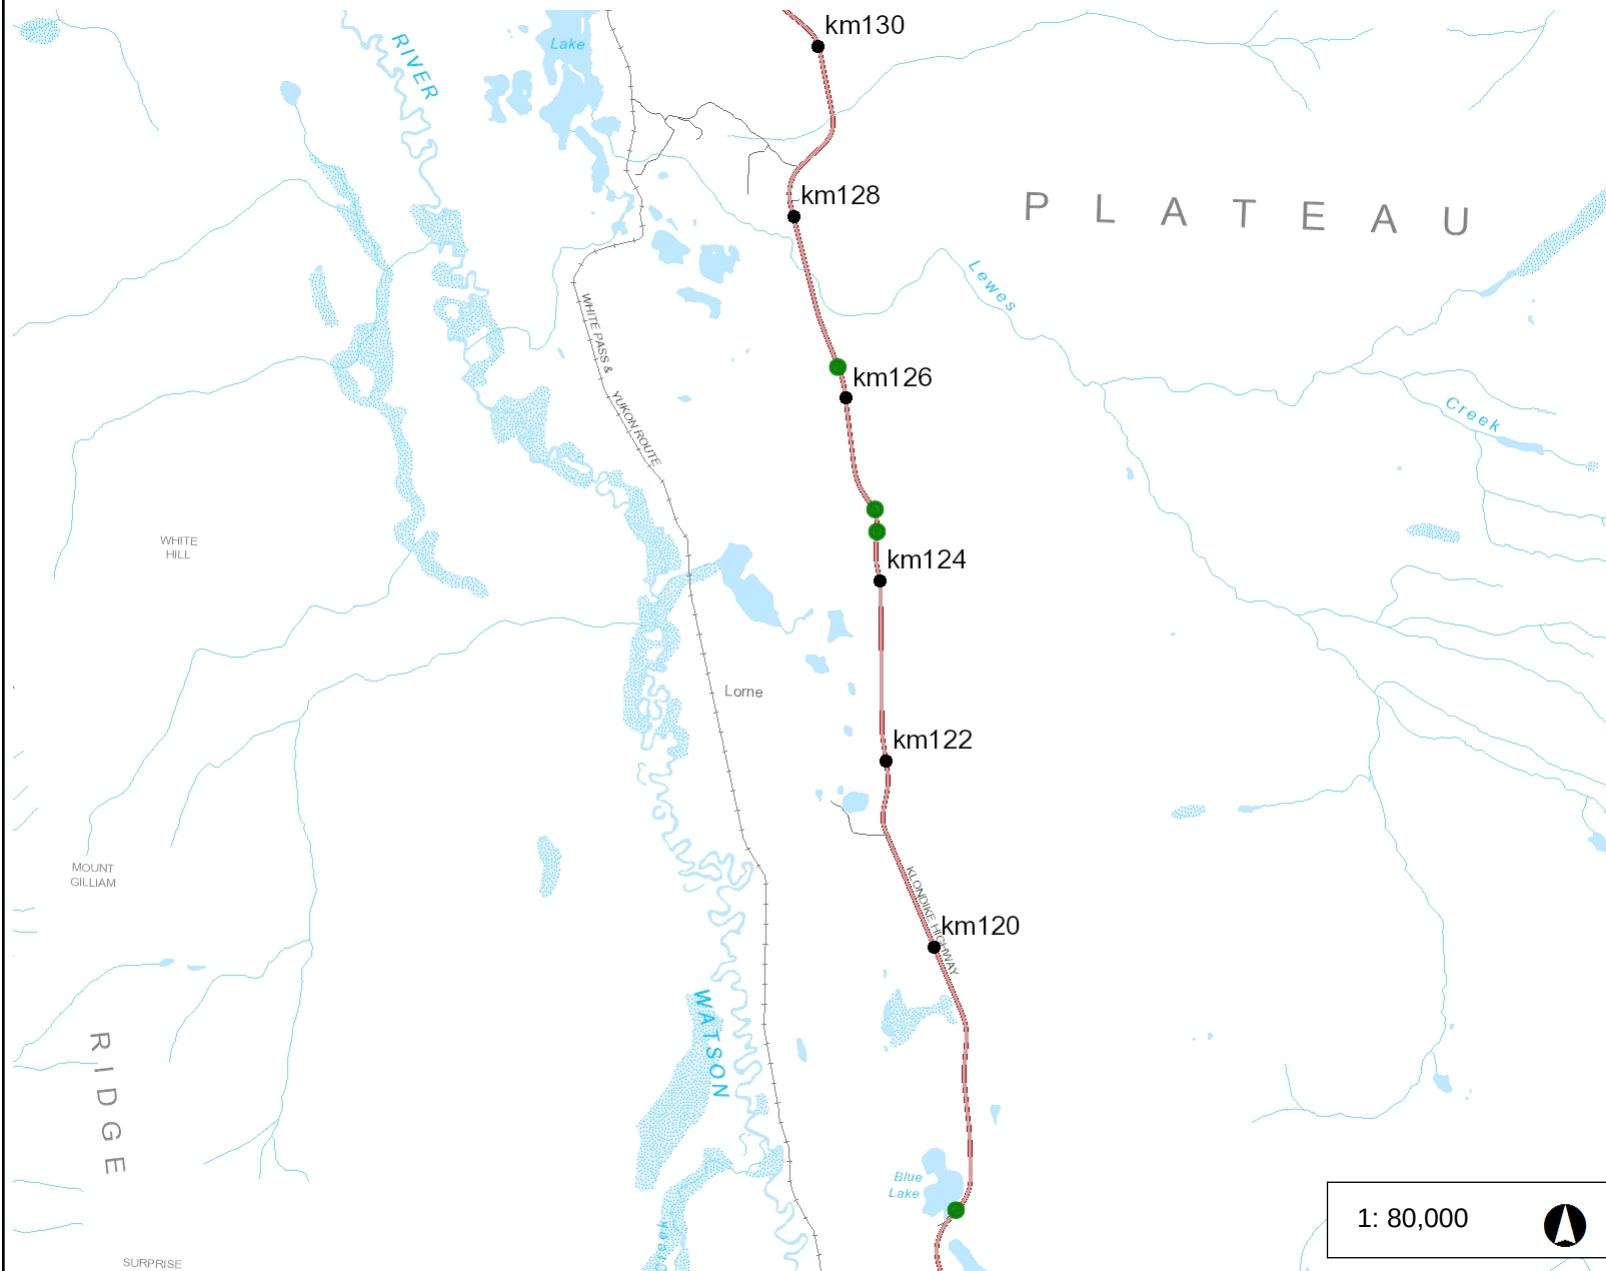
# Southern Lakes Roadways 2016 Invasive Plant Survey - S. Klondike Highway km 116-130

We briefly surveyed the two active gravel pits along the South Klondike Highway at km 129 (Lewes Lake) and km 151 (Mosquito Road). We only found a small infestation of sweetclover near the entrance of the km 151 pit. The other pit was free of invasives.
